UM WESTERN YOUTH CHALLENGE DINING HALL

Project: UM Western Youth Challenge Dining Hall
Location: **UM Western Campus**, Dillon, Montana
Owner: **State of Montana**
Architect: **Mosaic Architecture, P.C.**, 428 No. Last Chance Gulch, Helena, MT

Project Phase Submittal: Feasibility Study

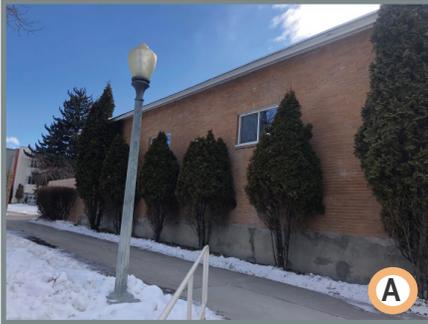
A

The north side of the building has no connection to the space outside nor does it allow passerbys to know what happens in the space.

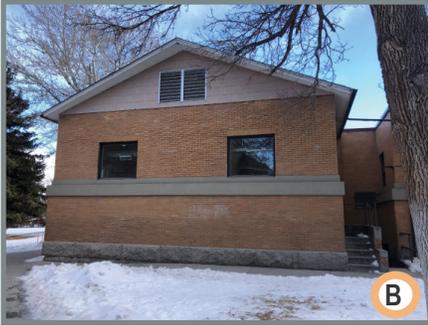
B

Siding is dated.

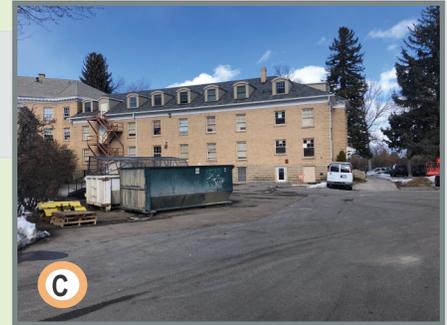
C

Dumpsters occupy most of the area, there is no clear pathway through the space. Walking through or utilizing this space as a student seems discouraged.

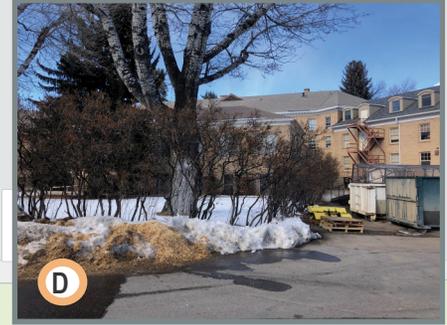
D

Small planting barrier exists, but there is no reason to go through the space, the route is blocked by service items.

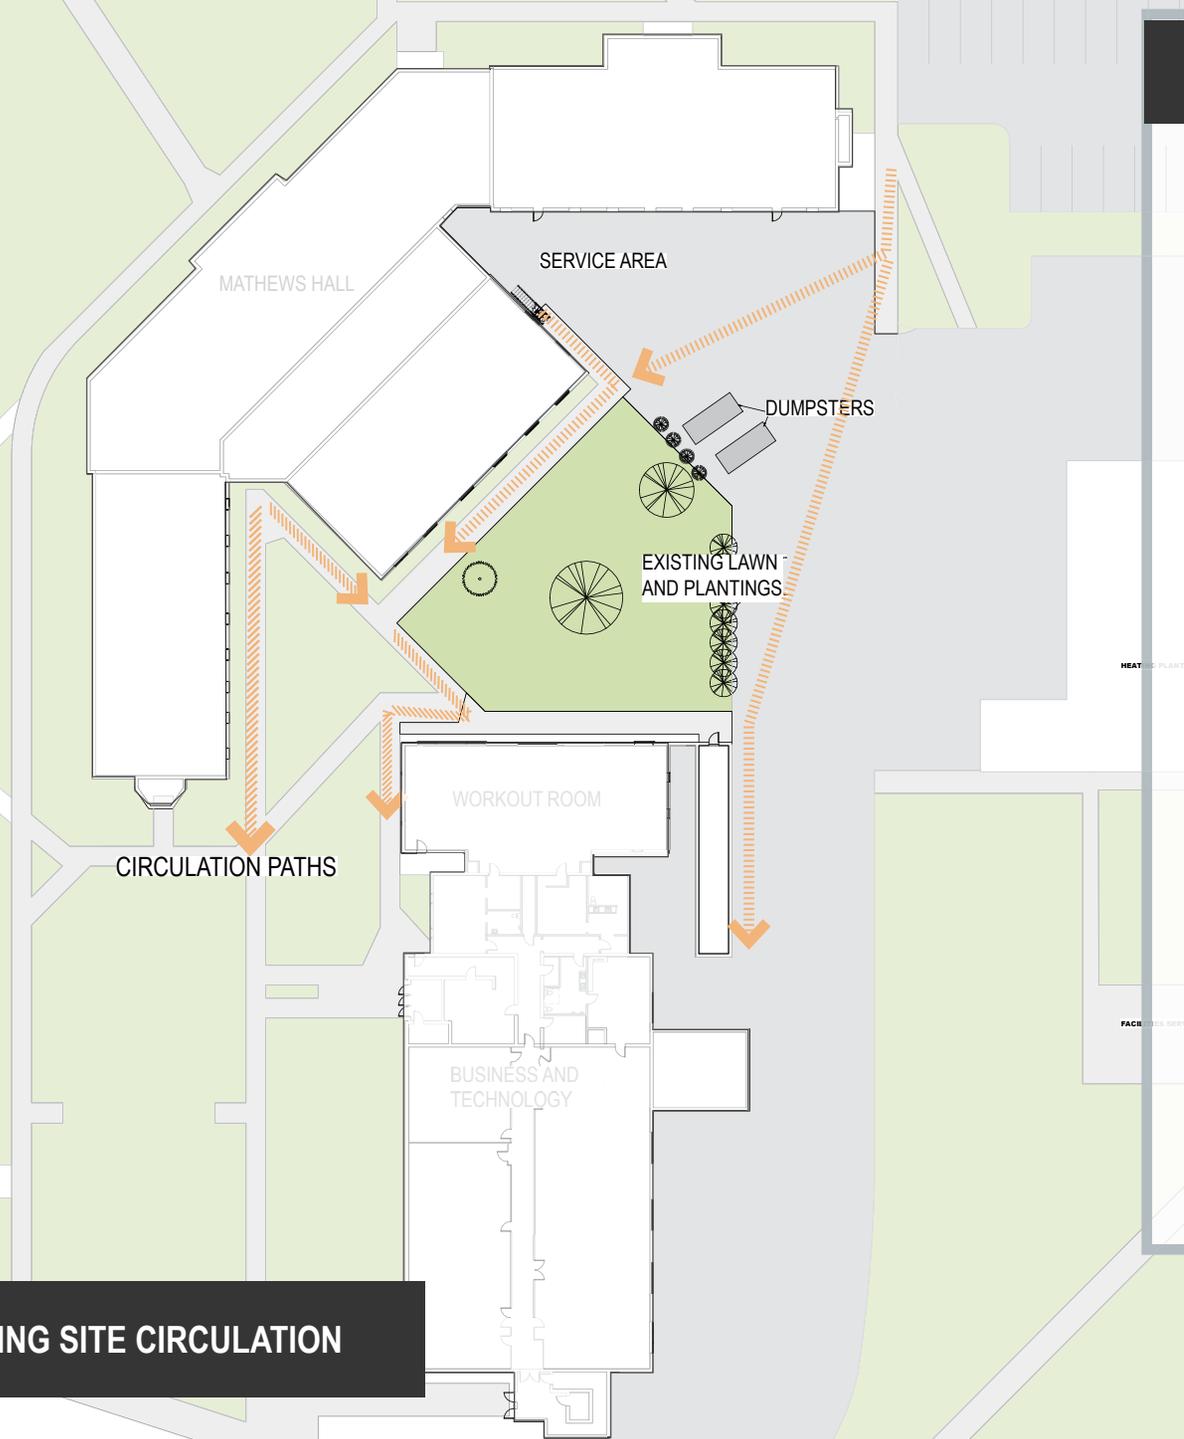
EXISTING SITE CIRCULATION

There is a desire to welcome students into the lawn between the buildings, and activate the space with additional pathways to draw students into and through the area. Additionally, there is a desire to establish some seating areas for eating outside. This space would be of use to both the Youth Challenge Academy and campus as a whole.

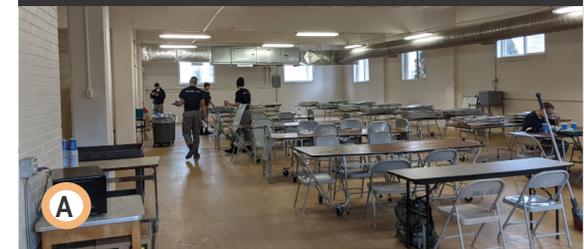
CURRENT DINING ROOM

Windows are too high for views, space is echo filled and loud, and no definition to guide usage of the space.

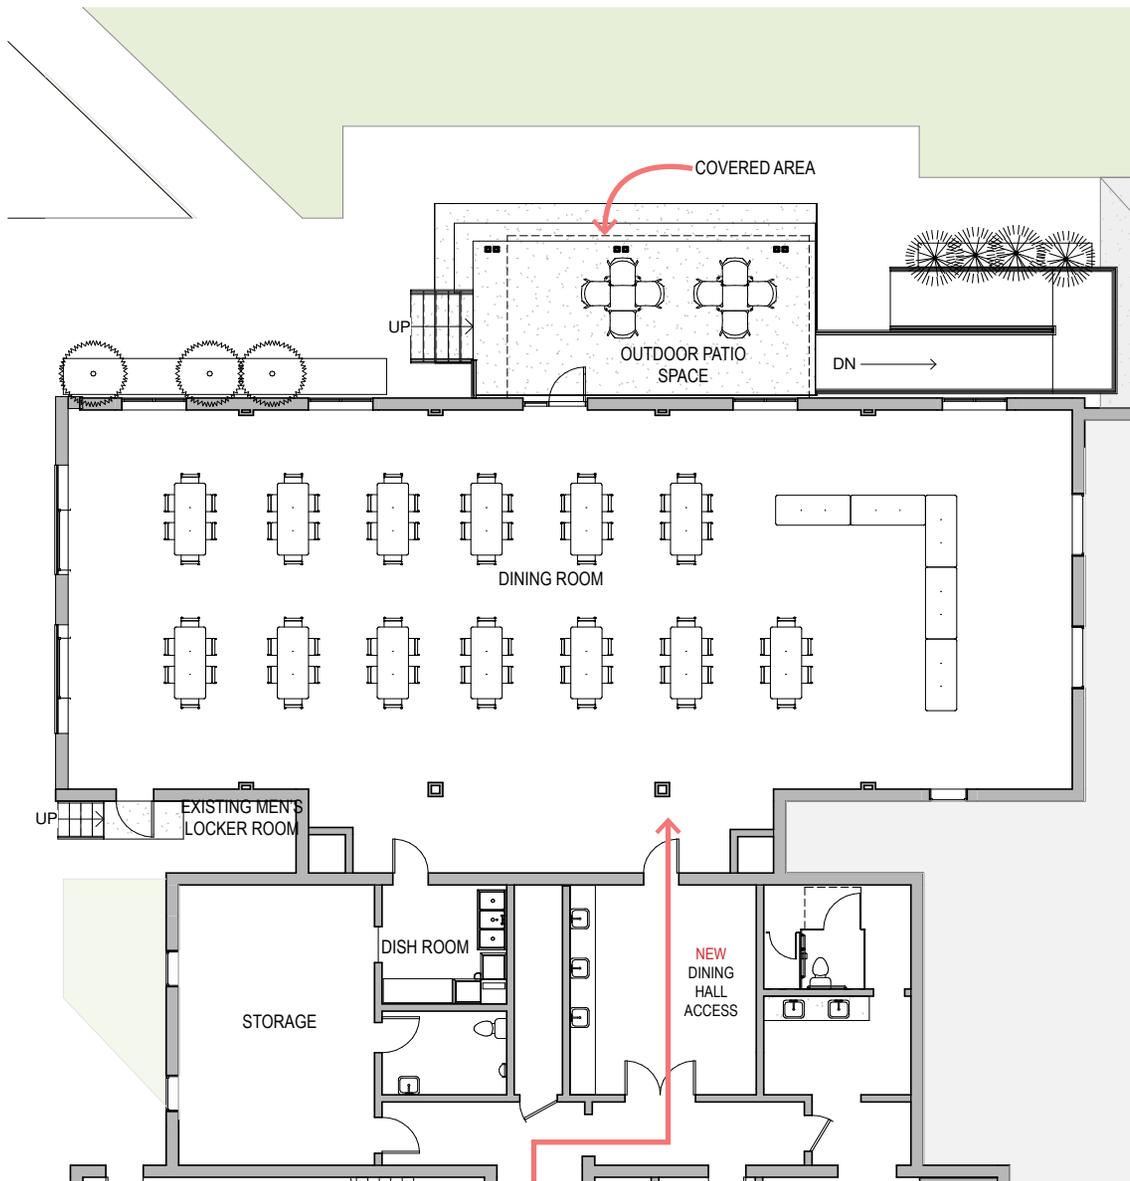
BUILDING LAYOUT

The remodel of the space focuses on expanding the windows and lowering the sills. The window sills will be brought down to 3 feet. This allows visual connection to the outside, but keeps the sill high enough to allow tables to be pushed against the wall.

Additionally one window is removed and a storefront door is put into the space. The door and the ramp can be used for service activities in addition to having a more accessible routes.

There is the possibility to create better access to the space through making the access hall/hand washing station the entryway into the hall. We have done and seen this scenario at other dining halls and it works well. Opening up the storage room and dish room to be used for those specific purposes. Moving the sink and adding a corner dishwasher into the room would also be undertaken at this time.

The bathroom remains accessible from the hallway as it was previously.

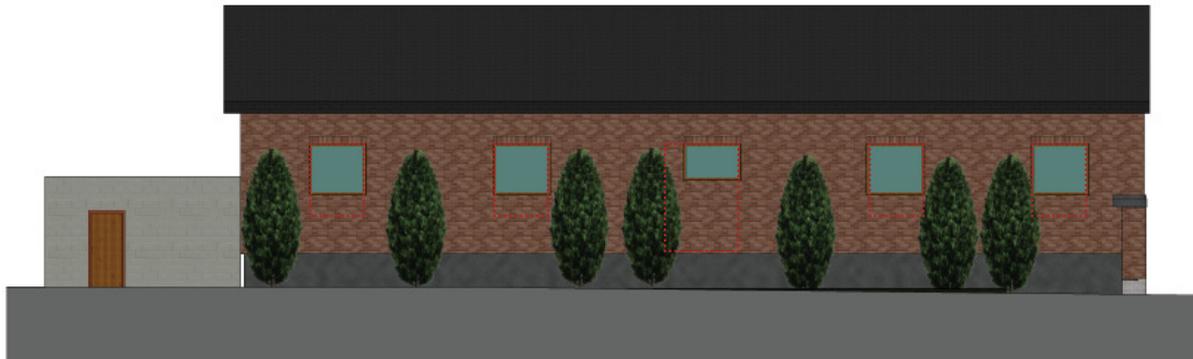
EXISTING ELEVATION

In the current elevation the building is closed off from the exterior and the occupants of the space are not part of the activities outside. There currently isn't even a visual linkage between the spaces.

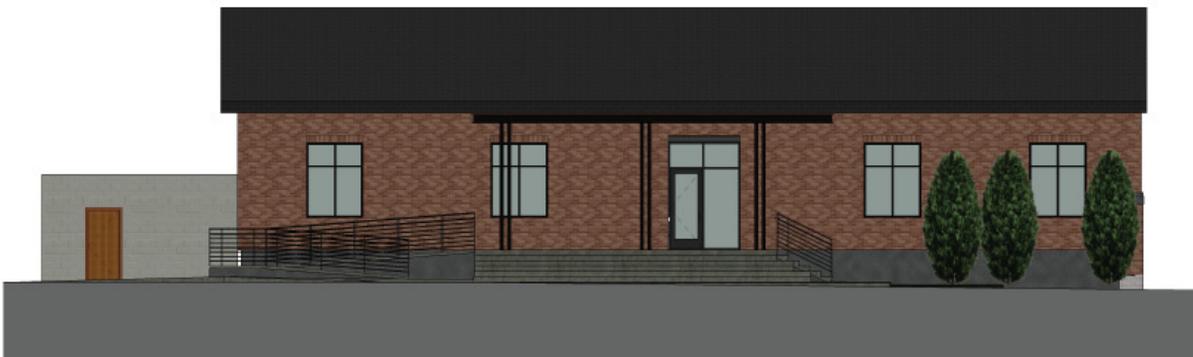
FUTURE ELEVATION

With the exterior remodel of the building the sill of the windows are dropped to 3'. Views and visual access between the spaces is established.

Adding a storefront door not only brings the space up to code and allows safe egress in an emergency situation, but allows access to the lawn and creates additional service routes from the space. The exterior patio space allows seating at tables and chairs and seating around the edges of the patio. This seating is not just for occupants of the dining hall but for occupants of Mathews Hall and all surrounding spaces.

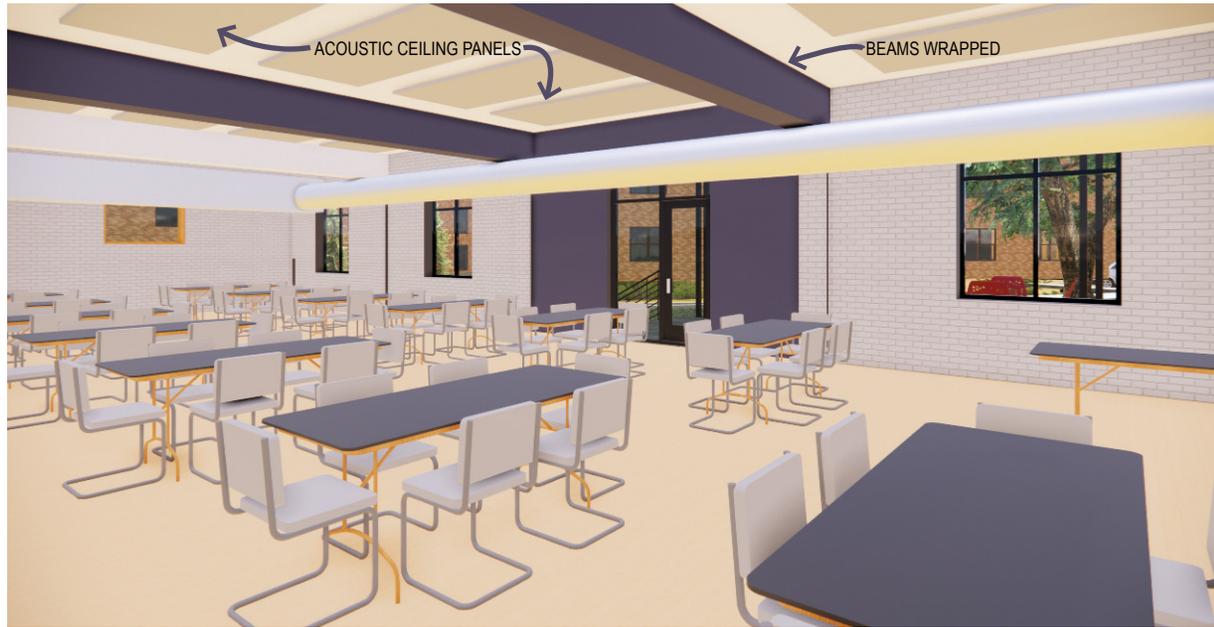
DINING ROOM

New windows have a sill height of 3' allowing someone to easily see out the window while sitting or standing. The center window is expanded into a storefront door. All beams across the ceiling are to be wrapped in gyp. board, the center bay of the wall and the columns to break up the space. The ceiling would have cleanable acoustic panels fixed to it throughout the space.

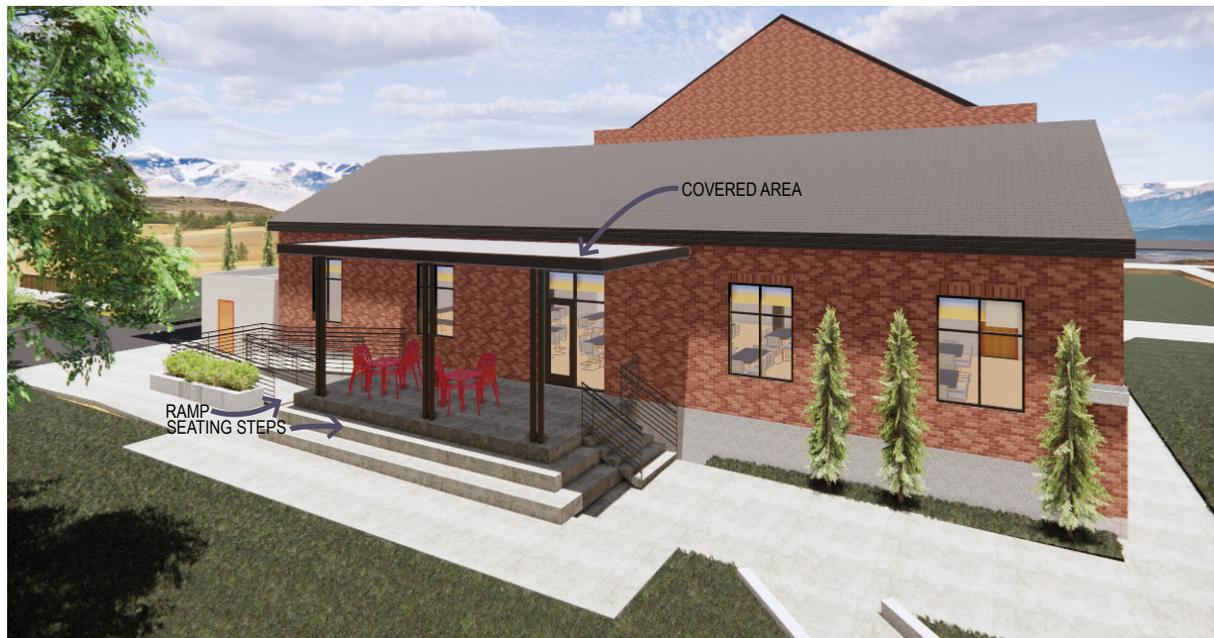
EXTERIOR SPACE

The patio outside the dining hall space has seating wrapping around the edges of the patio and the ramp. The ramp has been shifted to the far east end of the building to use for service uses in addition to being an accessible entrance. There are stairs coming up from the corner for easy access from both sides.

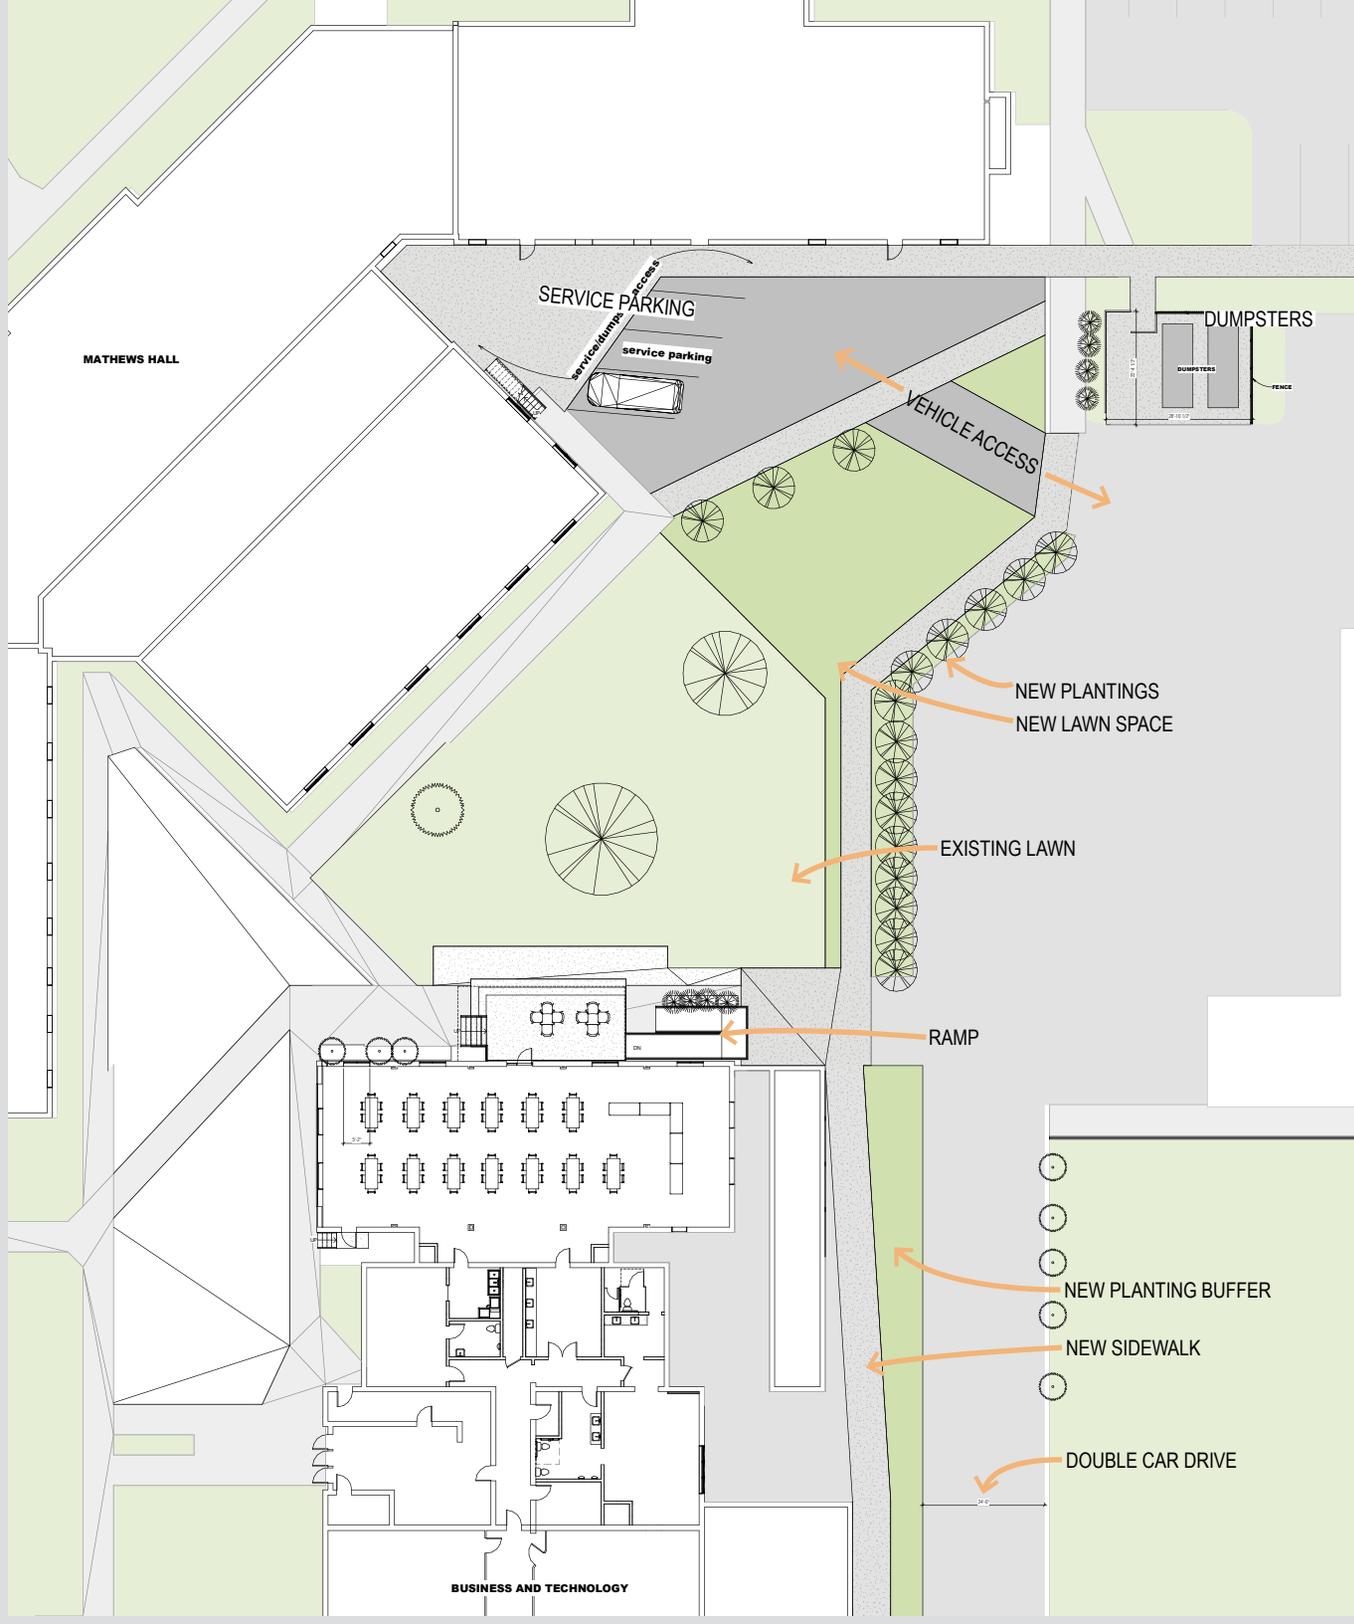
SITE LAYOUT-OPTION 1

The dumpsters will be moved farther to the north and placed into a fenced area. The service area for trucks is decreased but is still easily accessible and there is still plenty of room to back a supply truck in for kitchen deliveries.

The row of shrubs or trees on the east of the site will be extended along the new lawn and used to buffer the service areas from the area for people to congregate.

A defined walk down the East side of the business building would create a much friendlier pedestrian walkway. Additionally if we were to add a buffer of plantings, be it grass or shrubs it would further separate the pedestrian and vehicle routes. With both of these added there is still a 24' drive for service vehicles.

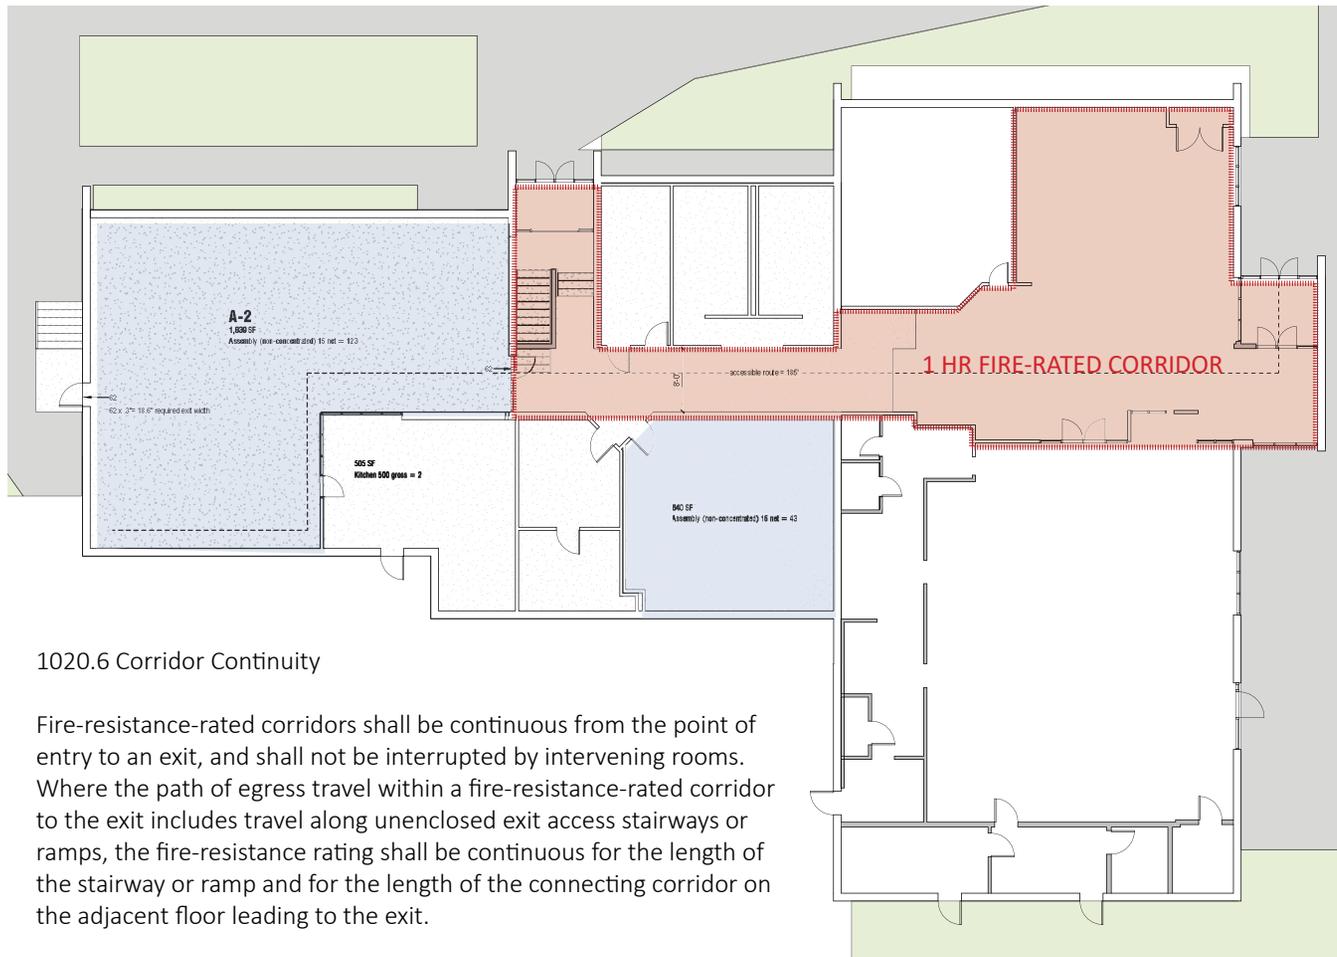
Due to the capacity of the building and its uses the corridor has to be 1HR Rated and protected from all other spaces. The only spaces allowed to be part of the 1 HR corridor are lobbies, foyers and reception rooms.

I am not confident that the 1HR rating extends into the lobby space to the north, but due to code I am assuming it does.

In order for any other space to be a part of the corridor it would have to be a foyer, lobby or reception room and the 1HR rating must encompass the included space.

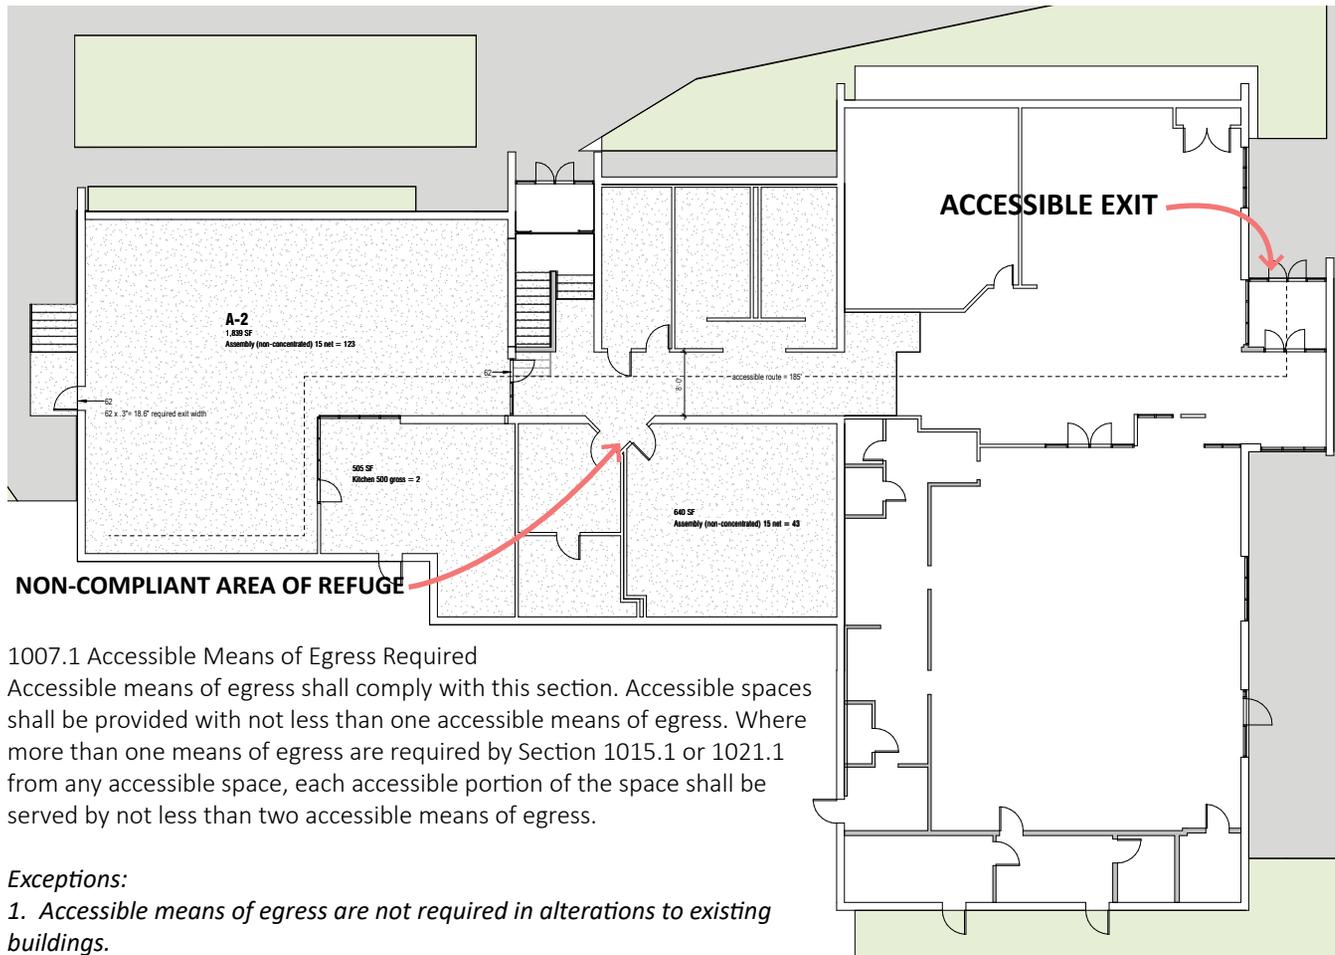
There are some accessible egress issues in the building that can be resolved in this renovation.

Accessible means of egress are not required in alterations to existing buildings per code. Currently the provided area of refuge does not meet the requirements of being a safe space to wait for assistance. This means the building has one exit for those who need assistance/ an accessible exit.

Through the addition of a safe area of refuge outside on the new patio addition the building and the methods of accessible egress from the building will be brought up to code. Since this can be accomplished while accomplishing the goals of the patio space, a safe area of refuge outside the exit door will be created.

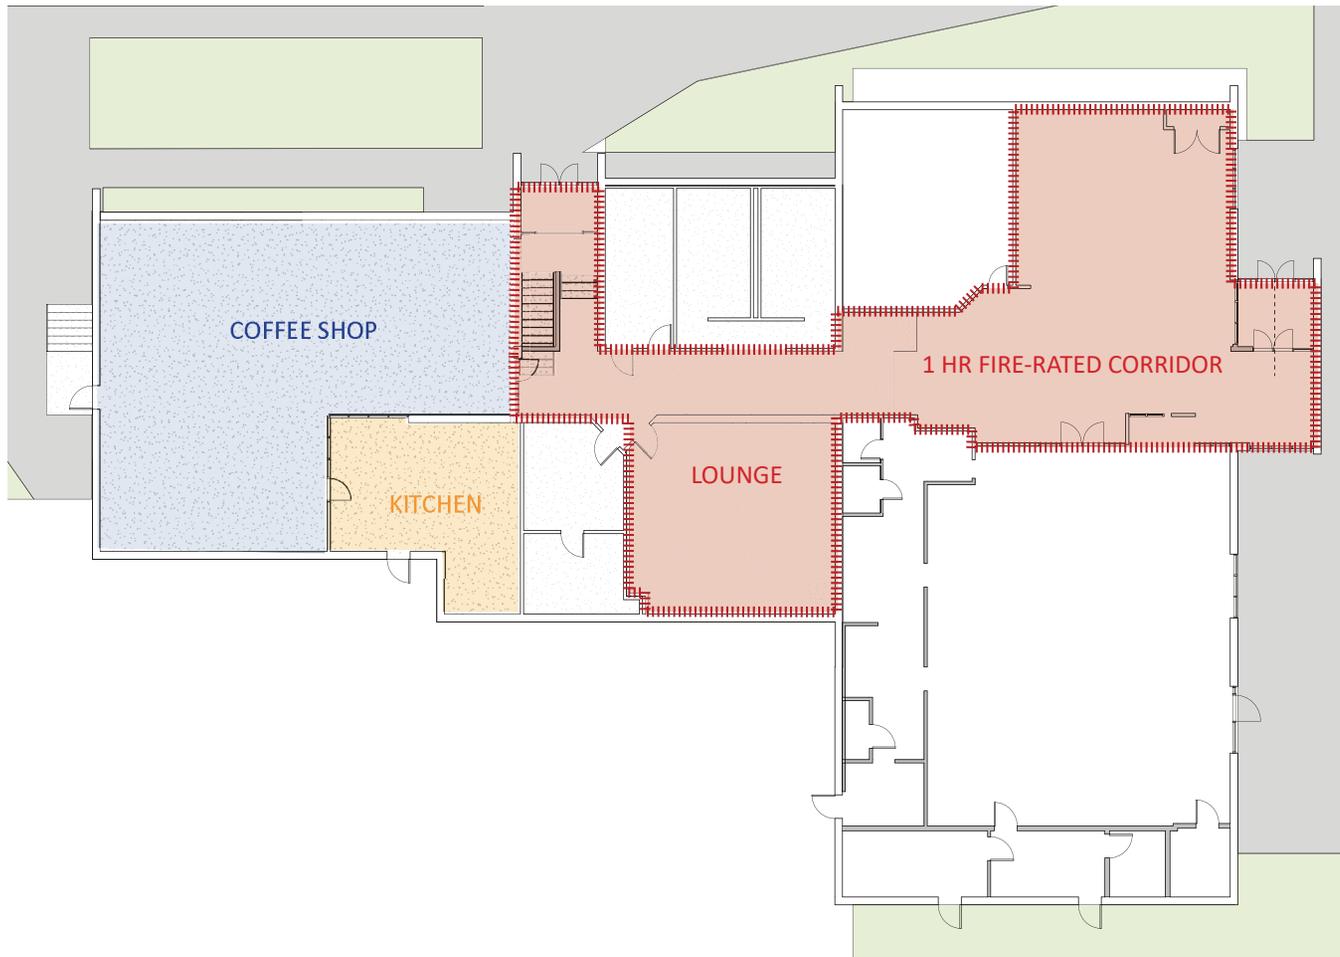
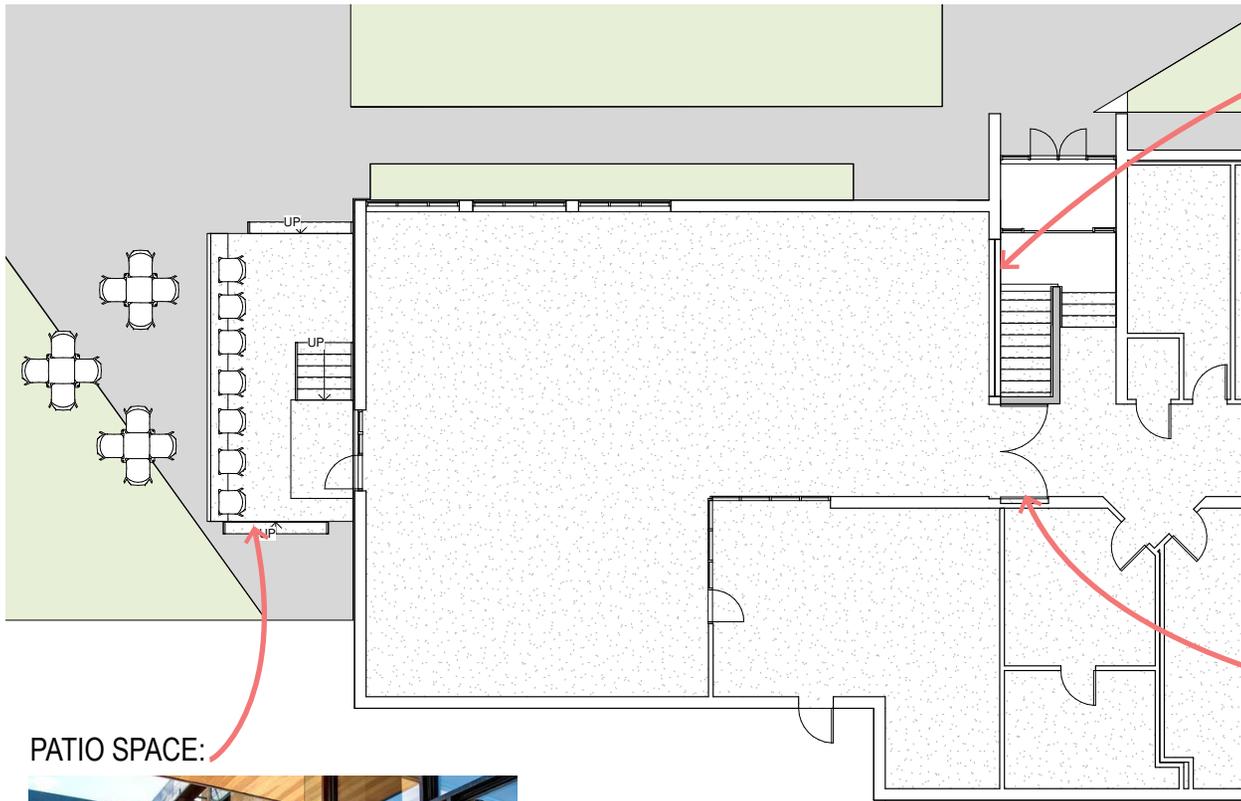
LOUNGE: The lounge space can be opened up if the one hour fire barrier is moved to encompass the space. This maintains a safe exit corridor and protects the space from the surrounding spaces.

COFFEE SHOP: The only spaces that can be combined with a 1hr rated corridor are lounges, foyers and reception rooms. The kitchen space which is connected to the coffee shop is a higher risk space. The fire corridor is a protected space for safe exit, putting a kitchen into the corridor compromises safety. There are methods to make the spaces feel open to one another while maintaining the 1HR fire rating.

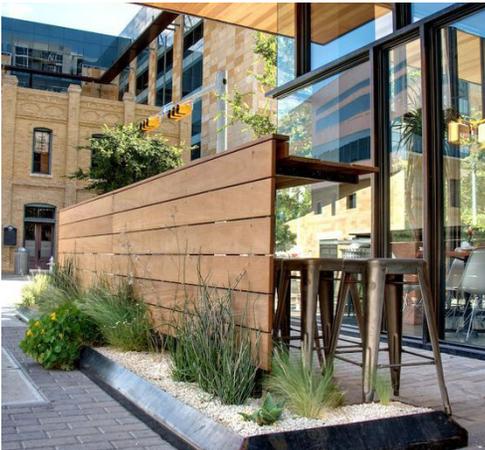
PATIO SPACE:

The possibilities for the patio space are numerous, the whole thing could be raised similar to the proposed Youth Challenge Patio space. It could be a small raised slab, or through simple bar seating and a couple low walls a defined patio space could be created.

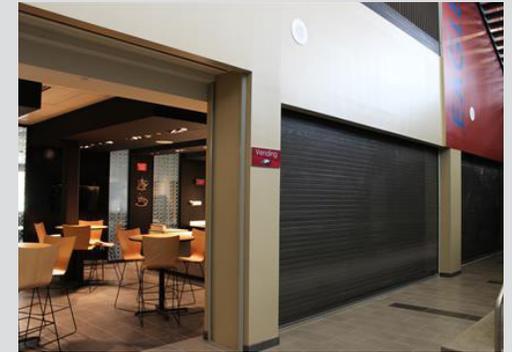
ROLL DOWN FIRE DOOR:

Through use of a fire door the spaces can be visually linked together and appear open and connected. In the event of fire, the doors would automatically roll down, and preserve the required 1hr fire rating of the hallway.

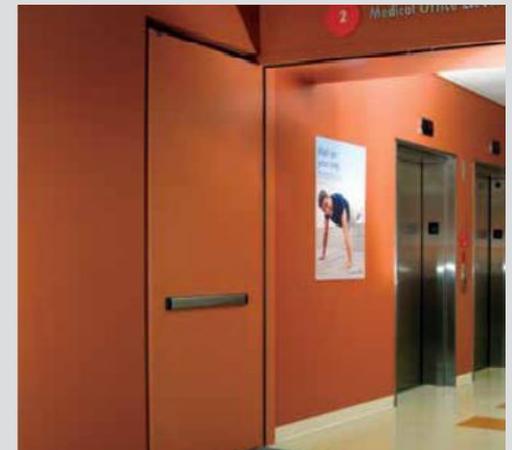
FLUSH MOUNTED FIRE DOORS:

Doors can be flush mounted to reduce their visual impact, and make the spaces appear linked. Again, in the event of fire these doors would close and preserve the 1hr rating of the corridor outside.
